TECHNICAL MEMORANDUM X-711

STRUCTURAL HEATING EXPERIENCES ON THE X-15 AIRPLANE* **

By Eldon E. Kordes, Robert D. Reed, and Alpha L. Dawdy

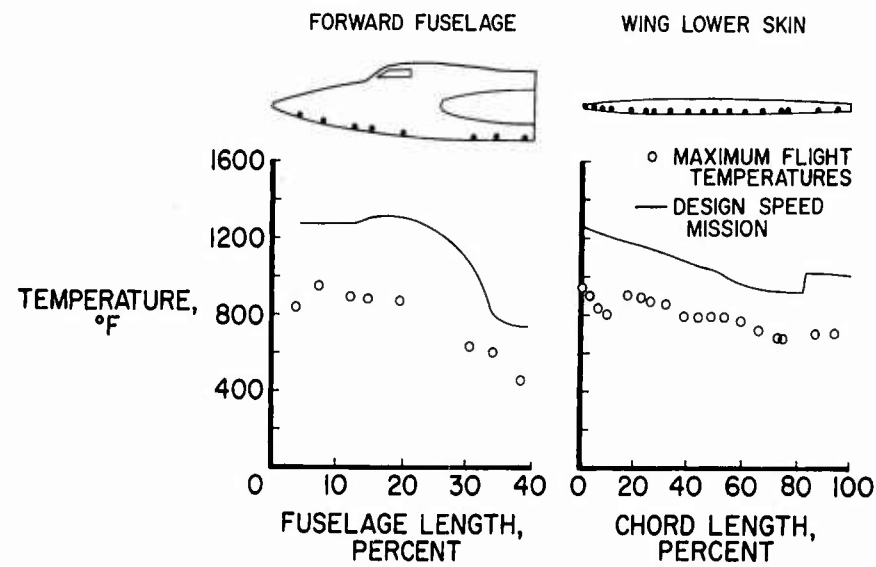
Figure 3

H
2
3
5
Distributions.- The maximum skin-temperature distribution measured on the flight to maximum speed is presented in figure 3. These temperatures occurred during the recovery portion of the flight several minutes after engine shutdown and, because of the maneuvers performed, cannot be attributed entirely to peak Mach number. Thermocouple locations for the forward fuselage and wing lower skin are shown by the solid symbols in the sketches and measured temperatures by the open symbols in the plots. The solid curves, included for reference, are for the calculated maximum temperature distribution for a design speed mission. The dip in the curves near the 5-percent fuselage station is attributed to the thicker skin in this region, and the rise is caused by the insulation in the cockpit area, which blocks internal radiation. The low temperatures near the 40-percent station are caused by the liquid-oxygen tank. On the wing, the higher temperatures near the trailing edge are a result of the thinner skin. Effects of the heat sink of the internal structure are not shown, since internal temperature measurements are not adequate. These data are the temperatures measured on a speed flight to a Mach number of 6.04 and are representative of the levels reached during the X-15 program. It should be mentioned that on all speed flights above a Mach number of 4, the maximum temperatures followed the same trends.

MAXIMUM SKIN TEMPERATURES

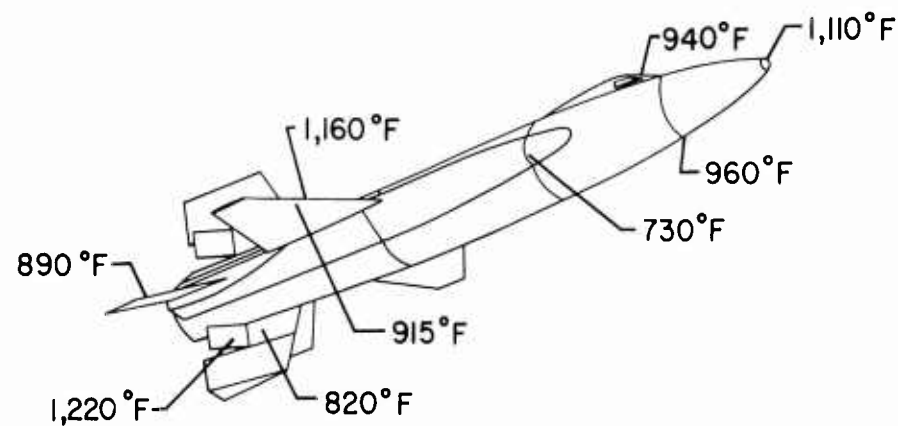
Figure 4

Locations.- The maximum temperatures measured at various points on the X-15 during the flight program are summarized in figure 4. Maximum temperatures are shown for the canopy frame, ball nose, lower fuselage, side fairings, lower wing skin, wing leading edge, lower ventral, lower speed brake, and horizontal tail. These maximum temperatures did not all occur on the same flight; however, they serve to illustrate the highest temperature levels that the structure has experienced up to this time, with the exception of local hot spots which are discussed subsequently.

SUMMARY OF MAXIMUM TEMPERATURES

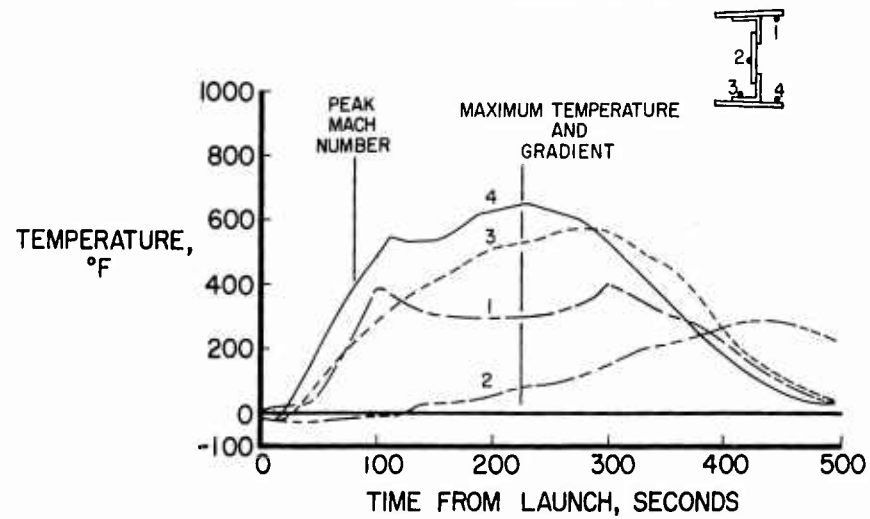
Figure 5

Temperature time history.- The temperatures presented thus far do not show variation during the flight or the gradient through the structure. In order to illustrate these quantities, typical temperature histories for the front spar of the wing at the midsemispan are presented in figure 5. These temperatures were measured on a flight to a maximum Mach number of 5.28.

WING-SPAR TEMPERATURES DURING
FLIGHT TO MACH NUMBER OF 5.28
FRONT SPAR MIDSEMISPAN

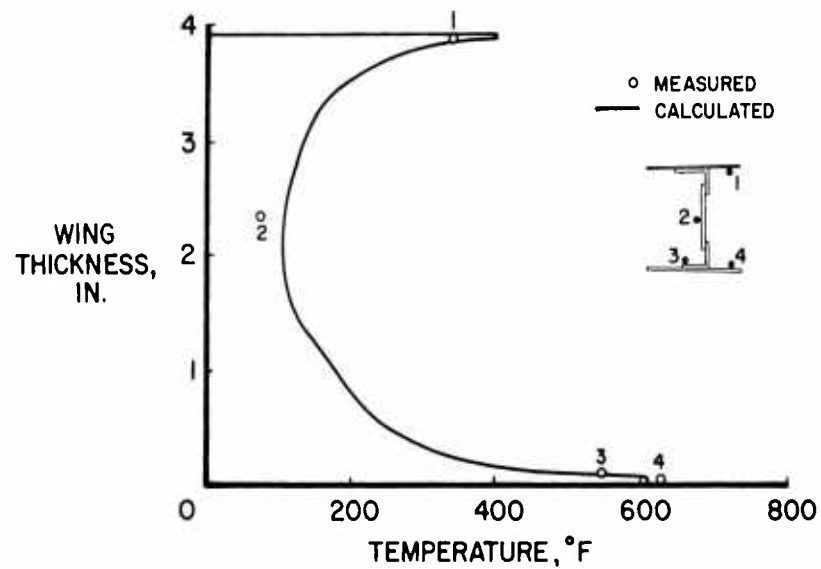
Figure 6

Temperature gradient.- From the standpoint of thermal stresses in the structure, the temperature gradient, together with the temperature level, defines the most severe condition on each flight. The measured data give the temperature levels but, with the limited number of thermocouples on the spar, the complete thermal gradient cannot be determined from flight measurements and must be obtained from analysis. Calculated gradients are compared with flight data for the time of maximum gradient in figure 6. The temperature is shown as a function of the wing thickness measured from the lower surface. The solid curve was obtained from calculations, and the points are from the flight measurements at the numbered points shown on the sketch. For these calculations, the heat transfer to the external skin was determined first on the basis of the time history for the skin temperatures by the method described in reference 1. This heat input was used to compute the thermal gradient through the spar and included 4 inches of each cover sheet. The spar cross section was divided into 30 elements for the calculations. The calculated and measured temperatures agree well at the four thermocouple locations shown in the sketch.

Calculated stress.- The thermal gradient in figure 6 has been used to calculate the thermal stresses in this isolated spar element. The stress calculations have neglected the interaction with the adjacent structure and are used primarily to monitor the changes in the thermal-stress level for various flight conditions. Calculated thermal stresses for the gradient shown are presented in figure 7. The curves on the right indicate the variation of normal stress through the spar, and the curves on the lower left show the variation of the normal stress in the lower skin. Included for reference are the thermal stresses calculated

CALCULATED SPAR TEMPERATURES AT
TIME = 225 SECONDS
FLIGHT TO MACH NUMBER OF 5.28
